Discover how automatic lubrication leads to **Extended Equipment Lifetime**

Why bearings fail

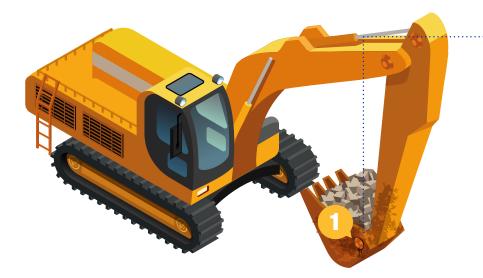
causes of wear A closer look at two major causes of bushing wear

Contamination

Contamination is caused by **environmental conditions.** Grease is not only the lubricant, it is also the barrier to contamination. Open lube points that lack fresh grease **allow dirt to easily enter the system.** Additionally, bad storage conditions — lids that are not properly closed — can allow contaminants such as dust and rain to enter the grease.

Dirty grease zerks

If zerks are not cleaned before manually lubricating with a grease gun, the dirt will be **pushed into the lube point,** creating wear that will **significantly reduce the lifetime** of the bearing or bushing. This will further result in equipment downtime and high repair and maintenance costs.
